WY2024 ANNUAL MONITORING SUMMARY

THE BIOLOGICAL OPINION FOR THE OPERATION AND MAINTENANCE OF THE CACHUMA PROJECT ON THE SANTA YNEZ RIVER IN SANTA BARBARA COUNTY, CALIFORNIA

**CACHUMA OPERATION AND MAINTENANCE BOARD
FISHERIES DIVISION**

MARCH 4, 2025

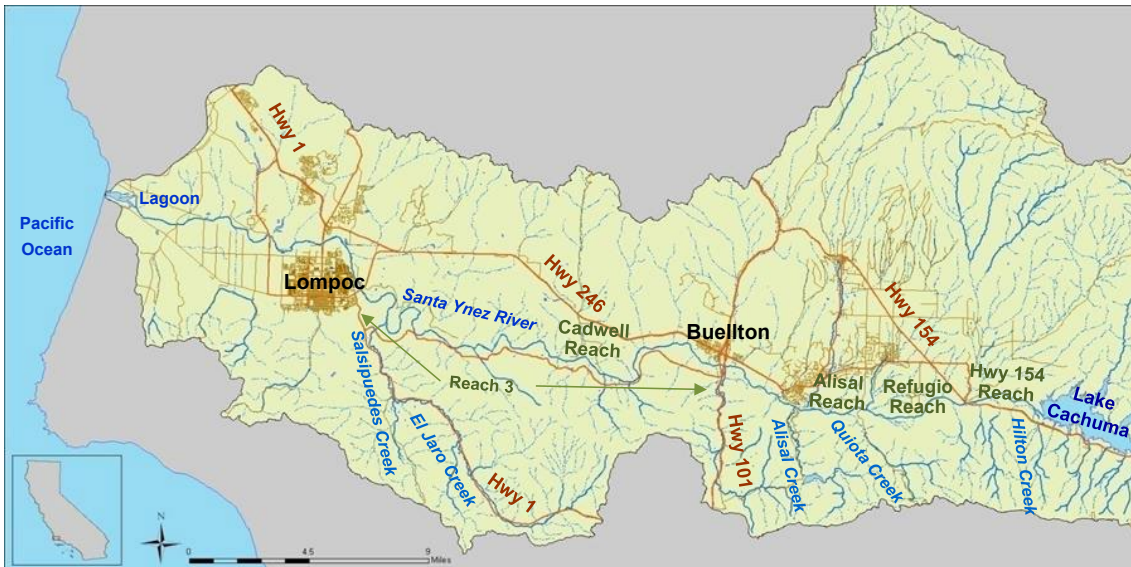
Figure ES-1: LSYR from Bradbury Dam and Lake Cachuma to the Pacific Ocean west of Lompoc, showing tributary creeks and management reaches of interest for the LSYR Fish Monitoring Program.

The monitoring tasks completed in WY2024 were performed below Bradbury Dam in the LSYR watershed and in Lake Cachuma, which is approximately half the drainage area (450 square miles) and stream distance (48 miles) to the ocean compared to the entire watershed. The area is within the Southern California Steelhead Distinct Population Segment (DPS) and the Monte Arido Highland Biogeographic Population Group (BPG) in the Southern Steelhead Recovery Planning Area (NMFS, 2012). Monitoring focused on three management reaches (Highway [Hwy] 154, Refugio, and Alisal reaches) and Reach 3 specifically the Cadwell Reach on the LSYR mainstem, and tributaries (Hilton, Quiota, El Jaro, and Salsipuedes creeks) known to support suitable habitat for *O. mykiss* (Figure ES-1).

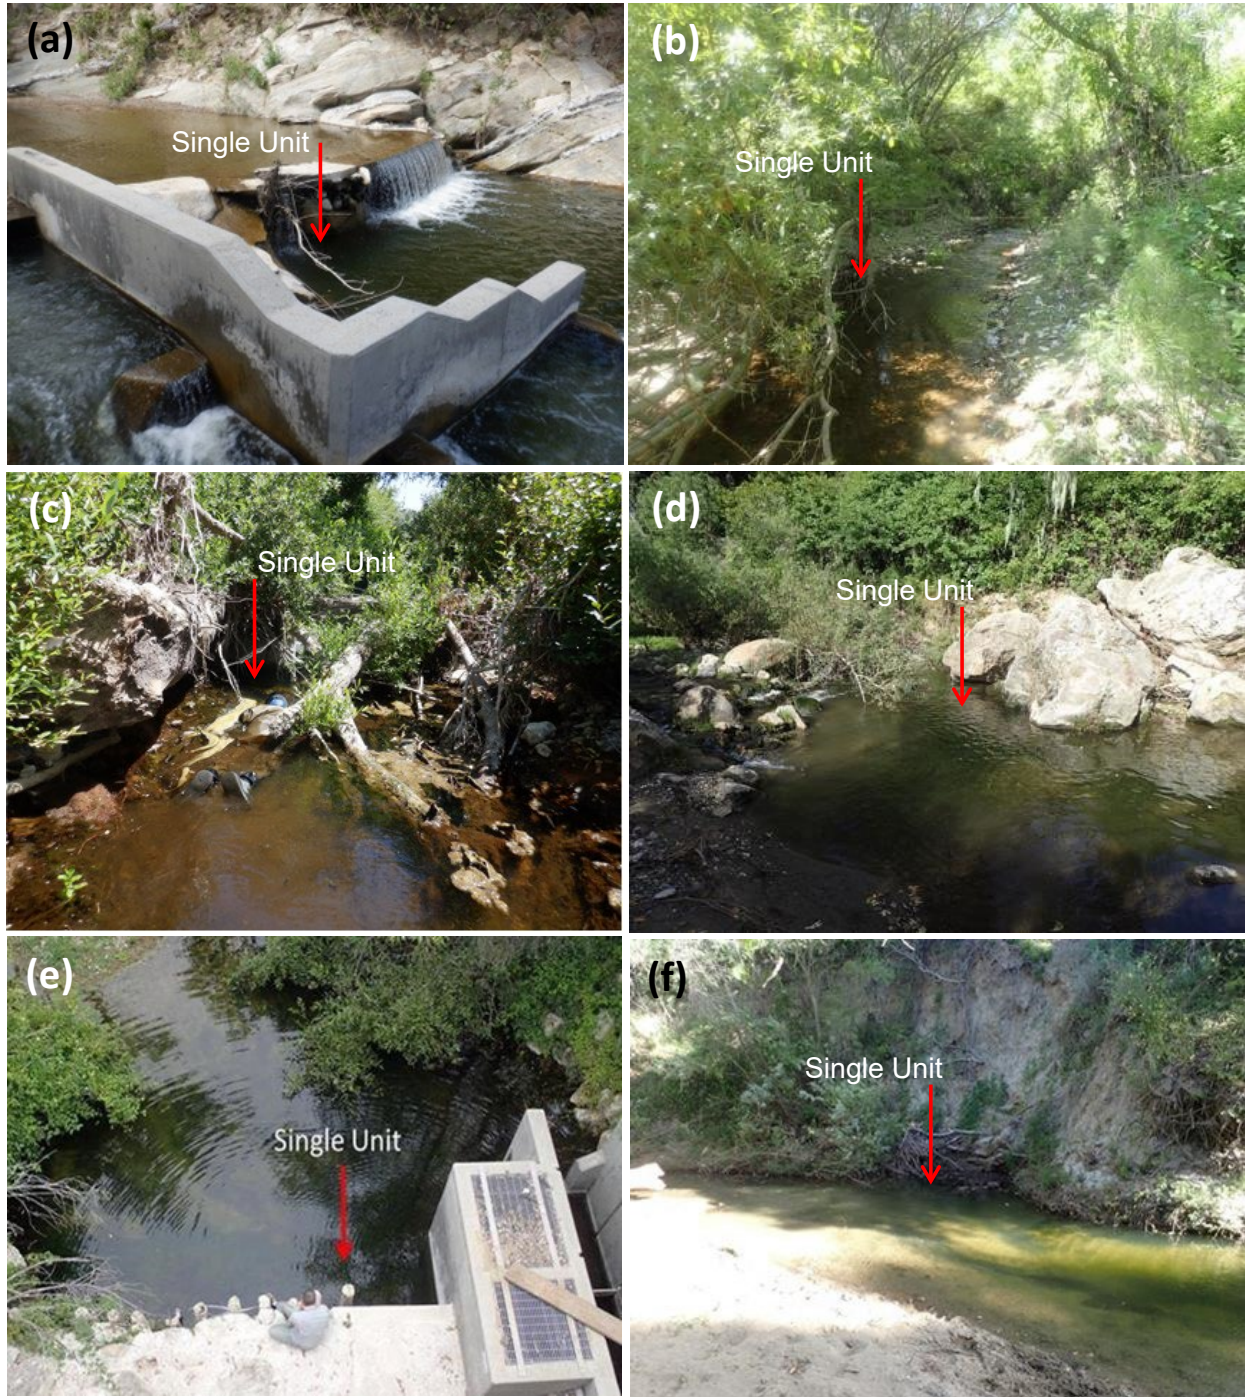
Figure 10: 2024 Tributary thermograph deployment locations at: (a) SC-3.5, (b) SC-3.8, (c) EJC-3.81, (d) EJC-5.4, (e) EJC-10.82, and (f) LAC-7.0.

Figure 10: 2024 Tributary thermograph deployment locations at: (a) SC-3.5, (b) SC-3.8, (c) EJC-3.81, (d) EJC-5.4, (e) EJC-10.82, and (f) LAC-7.0.

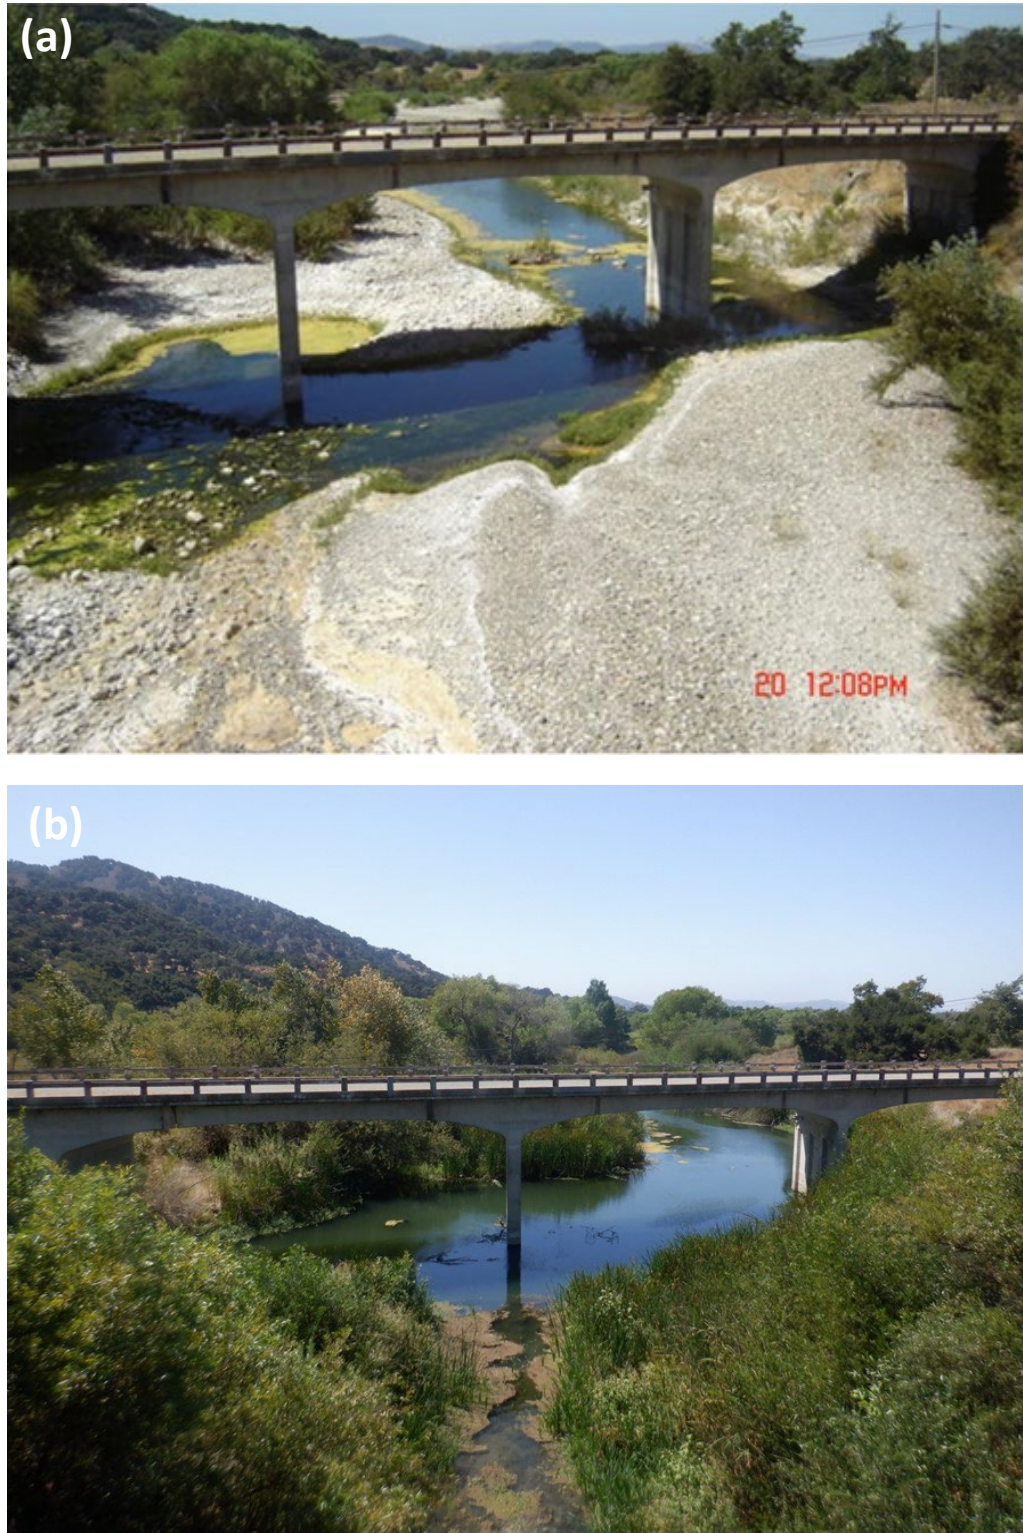
Figure 58: Photo points (M-6) collected at Highway 154 Bridge looking downstream in (a) September 2005 and (b) September 2024.

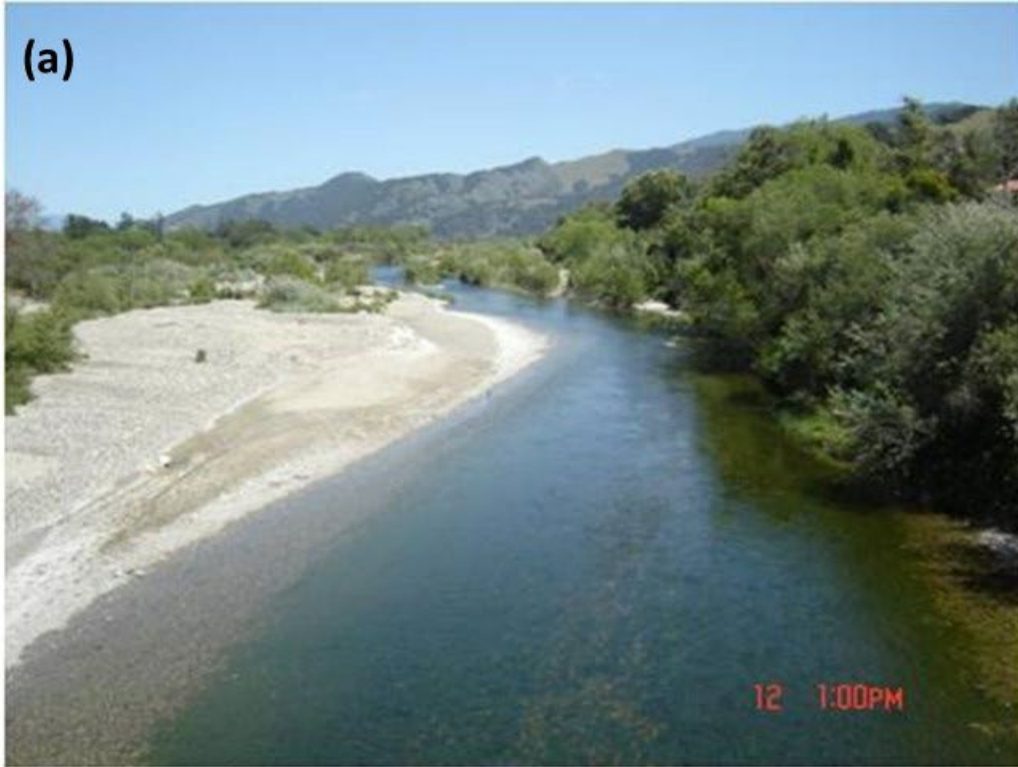
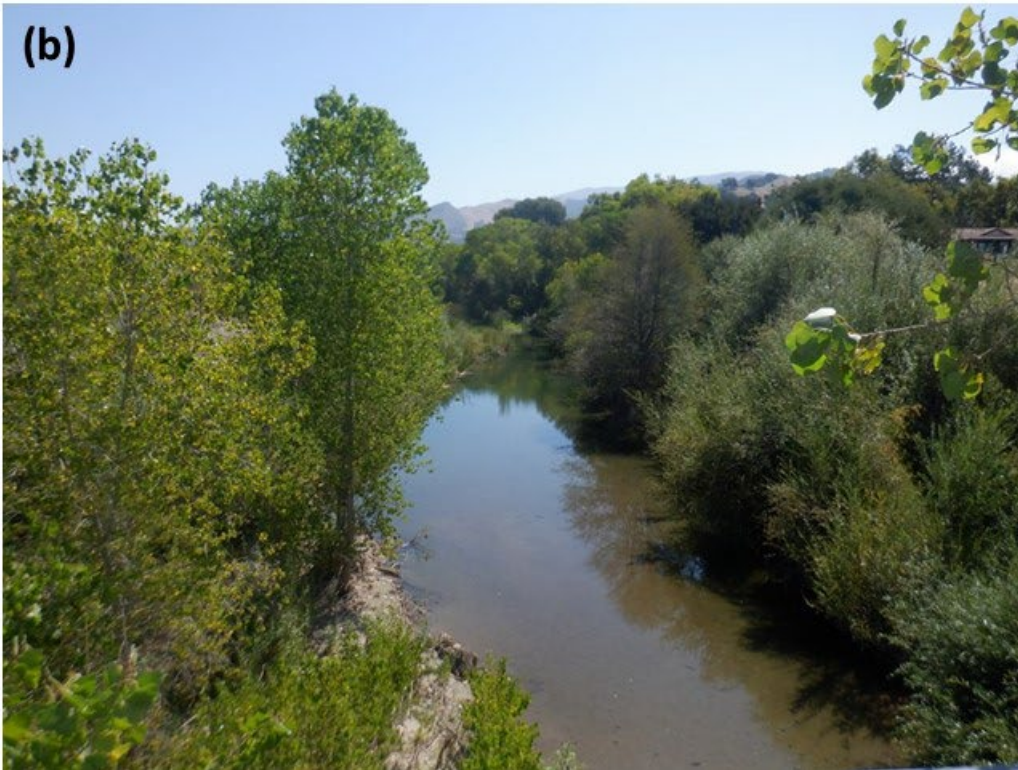
Figure 59: Photo point (M-12) collected at Refugio Bridge looking upstream in (a) May 2005, and (b) September 2024.

Figure 59: Photo point (M-12) collected at Refugio Bridge looking upstream in (a) May 2005, and (b) September 2024.

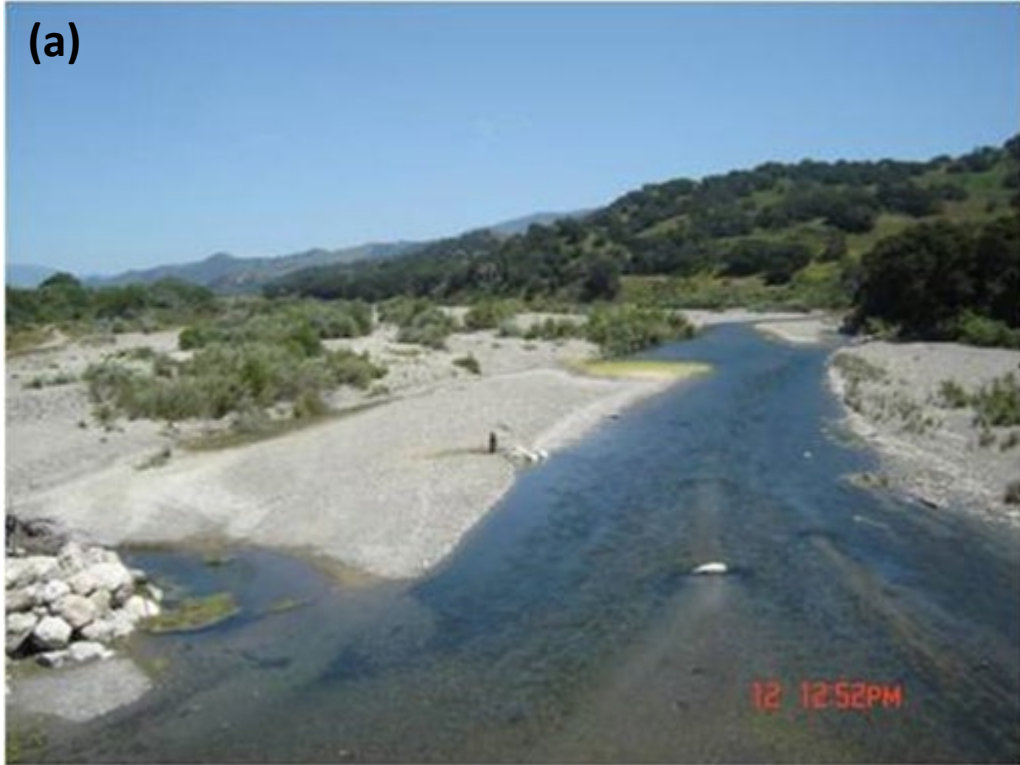
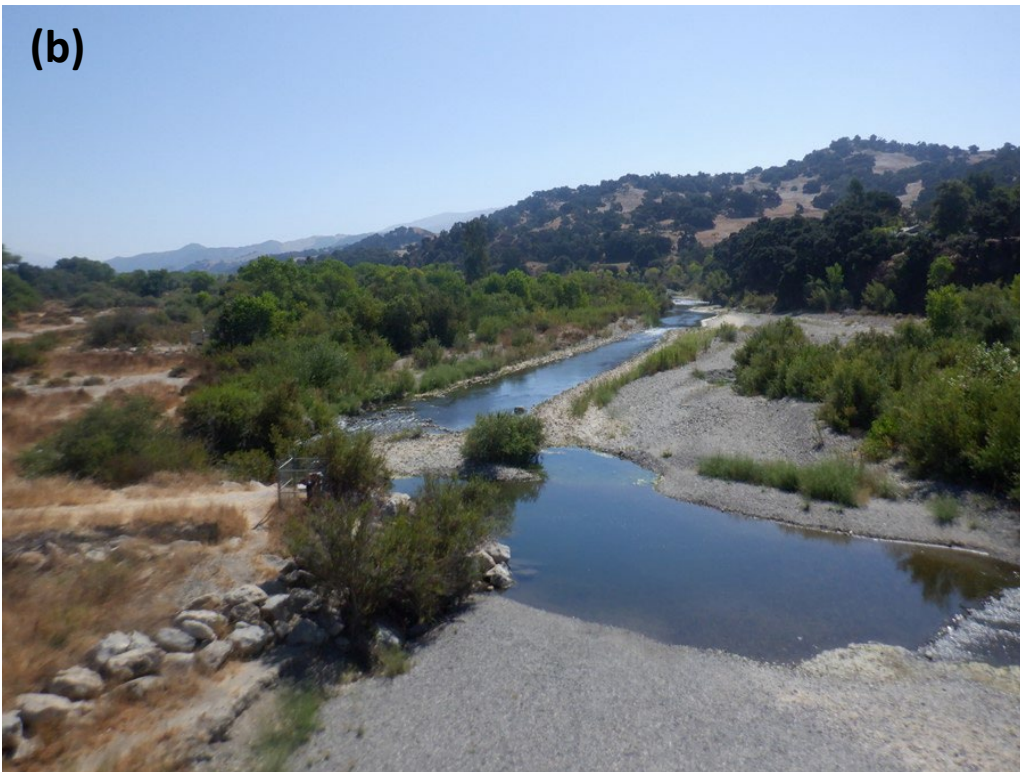
Figure 60: Photo point (M-14) collected at Alisal Bridge looking upstream in (a) May 2005, and (b) September 2024.

Figure 60: Photo point (M-14) collected at Alisal Bridge looking upstream in (a) May 2005, and (b) September 2024.

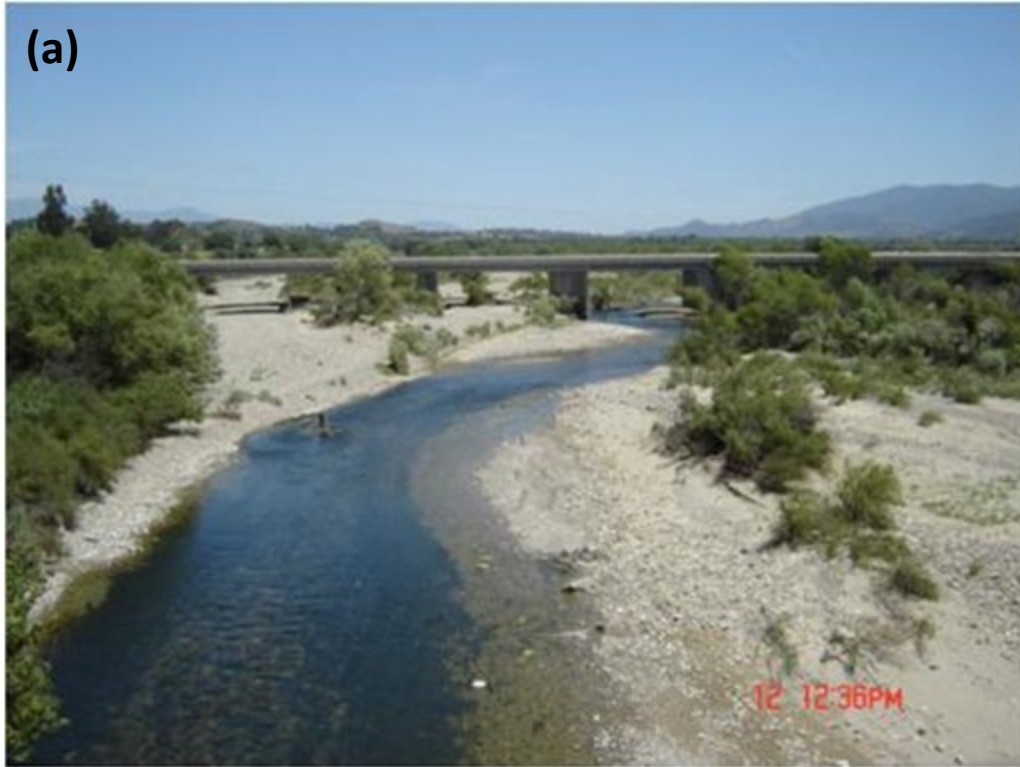
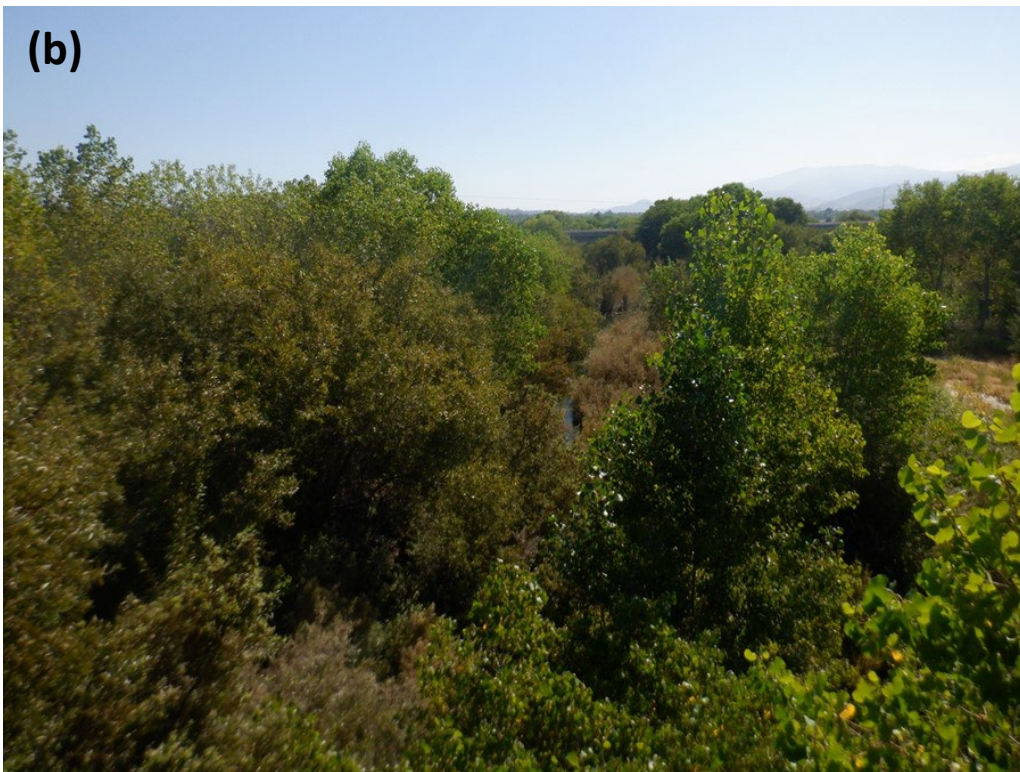
Figure 61: Photo point (M-19) collected at Avenue of the Flags Bridge looking upstream in (a) May 2005, and (b) September 2024.

Figure 61: Photo point (M-19) collected at Avenue of the Flags Bridge looking upstream in (a) May 2005, and (b) September 2024.

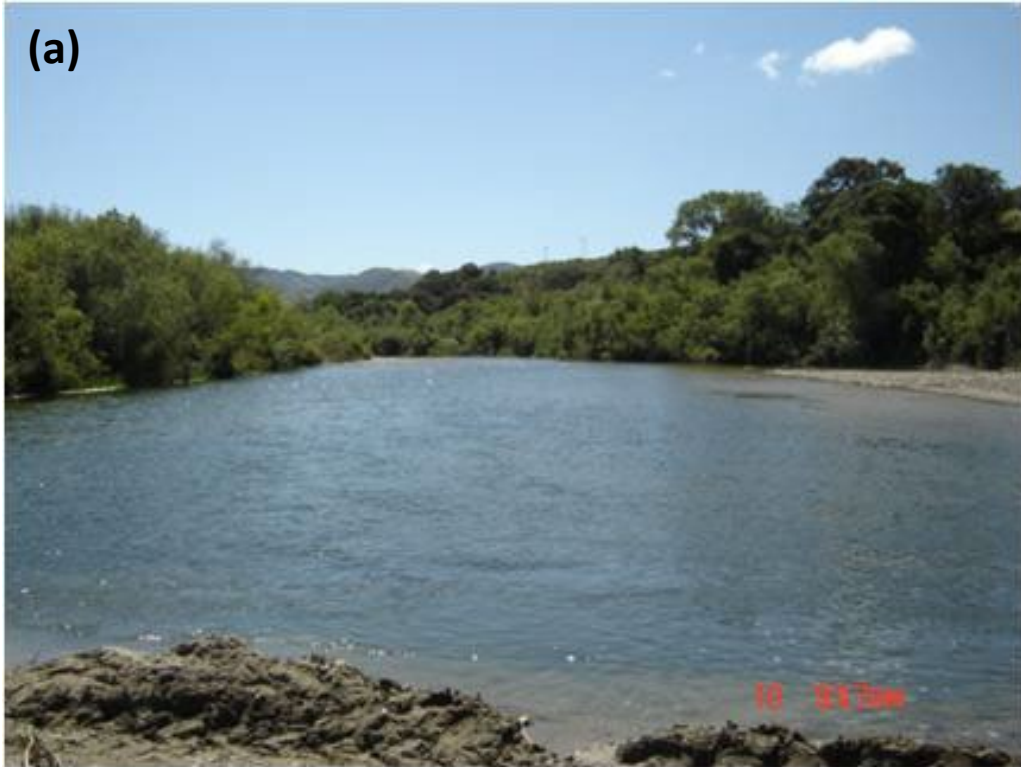
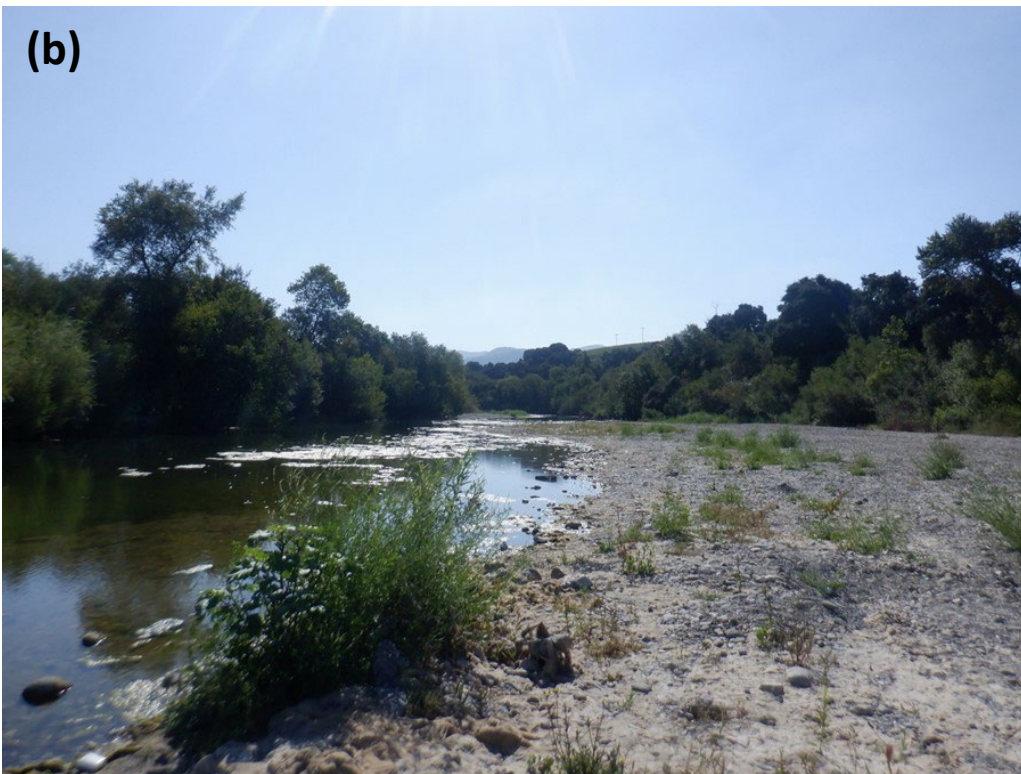
Figure 62: Photo point (M-21) collected at Sweeney Road Crossing looking upstream in (a) May 2005, and (b) September 2024.

Figure 62: Photo point (M-21) collected at Sweeney Road Crossing looking upstream in (a) May 2005, and (b) September 2024.

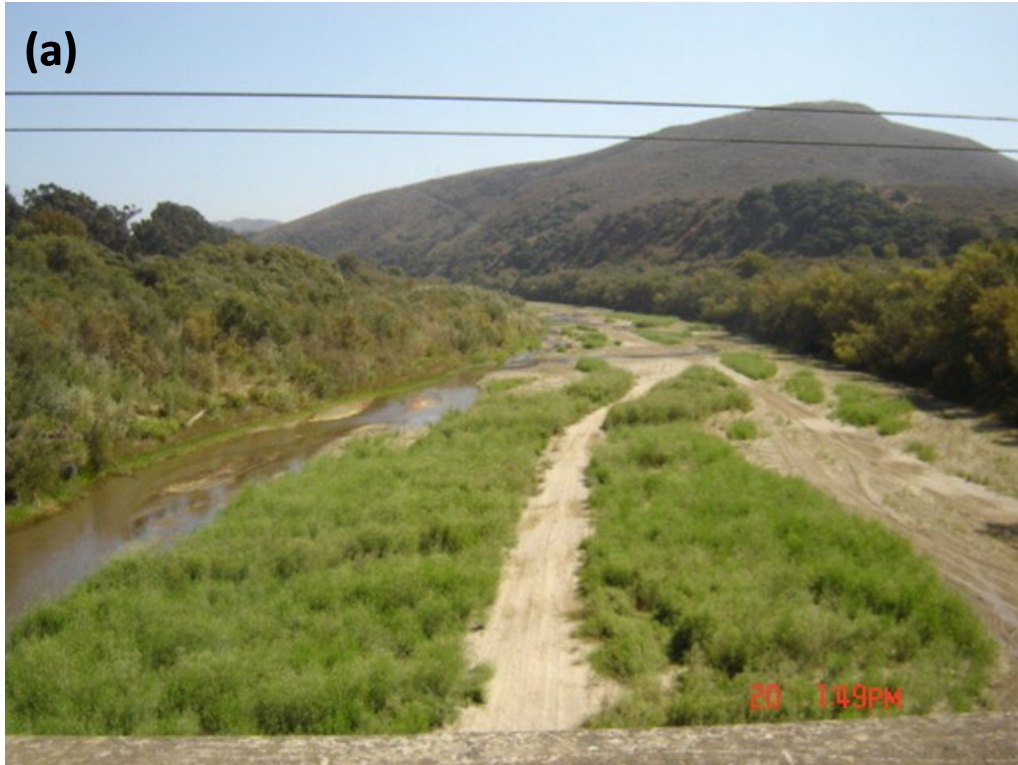
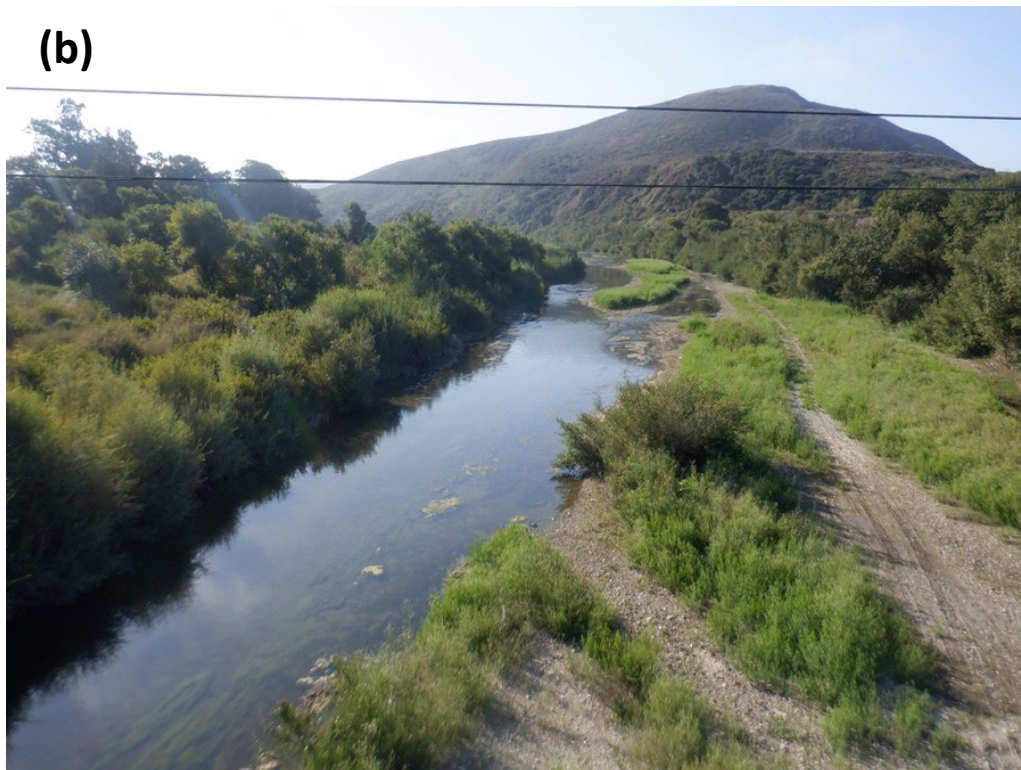
Figure 63: Photo point (M-23) collected at Robinson Bridge looking upstream in (a) September 2005, and (b) September 2024.

Figure 63: Photo point (M-23) collected at Robinson Bridge looking upstream in (a) September 2005, and (b) September 2024.

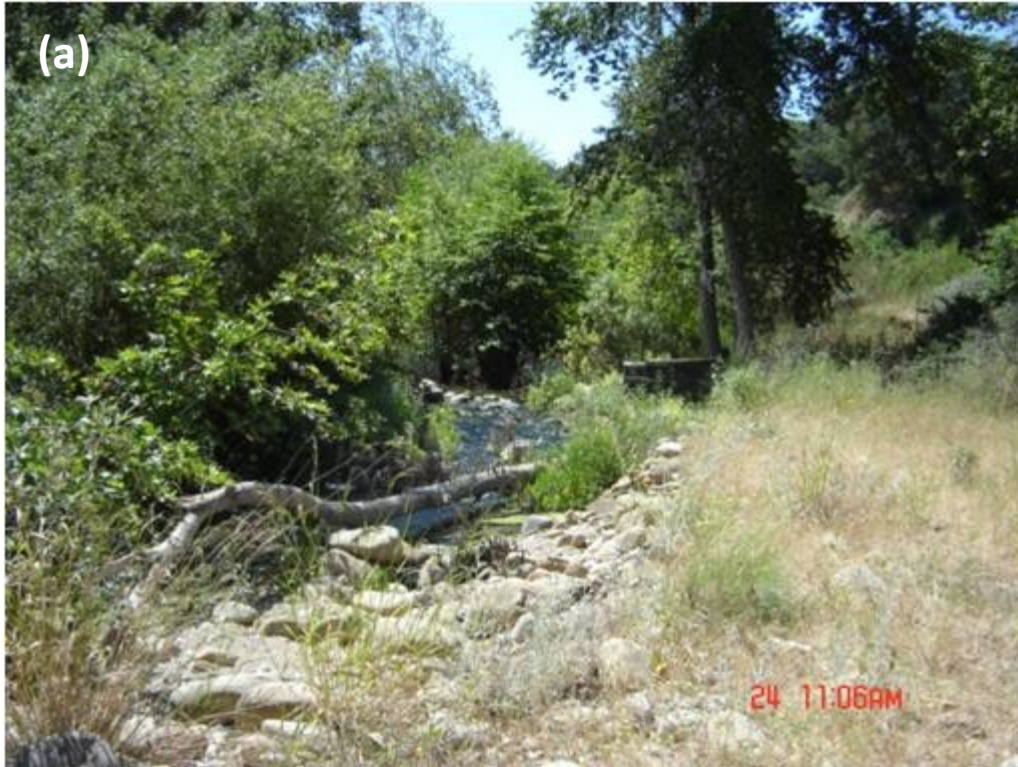
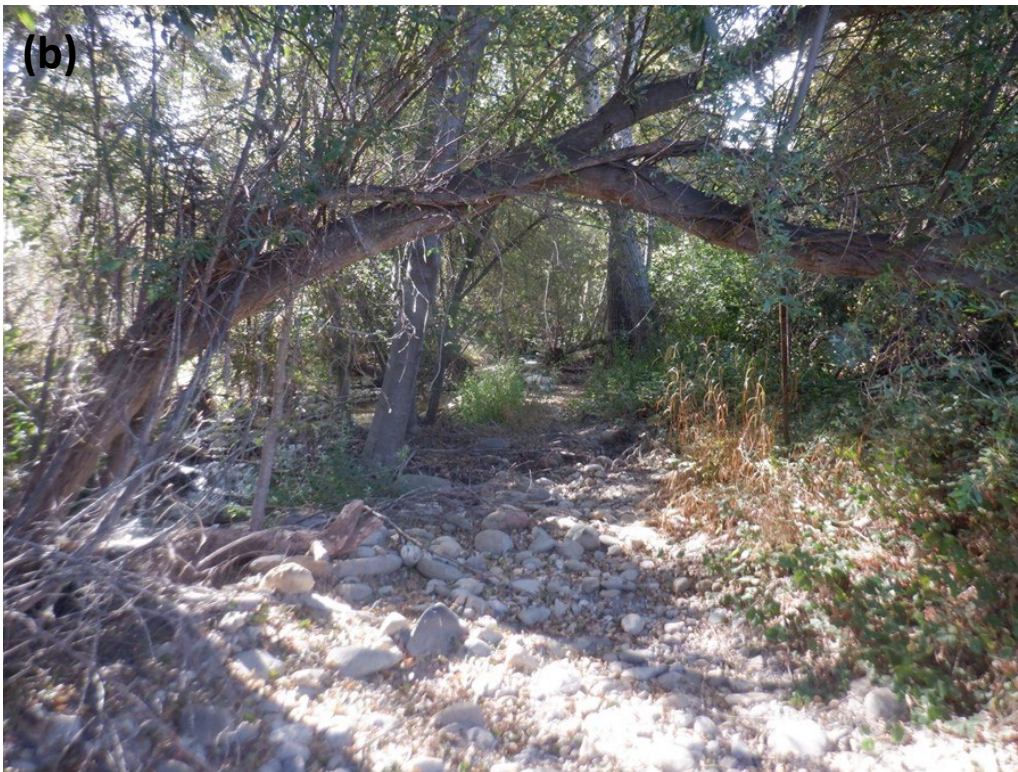
Figure 64: Photo point (T-1) collected at Hilton Creek looking upstream towards the trap site on (a) May 2005, and (b) September 2024 (the creek is to the left).

Figure 64: Photo point (T-1) collected at Hilton Creek looking upstream towards the trap site on (a) May 2005, and (b) September 2024 (the creek is to the left).

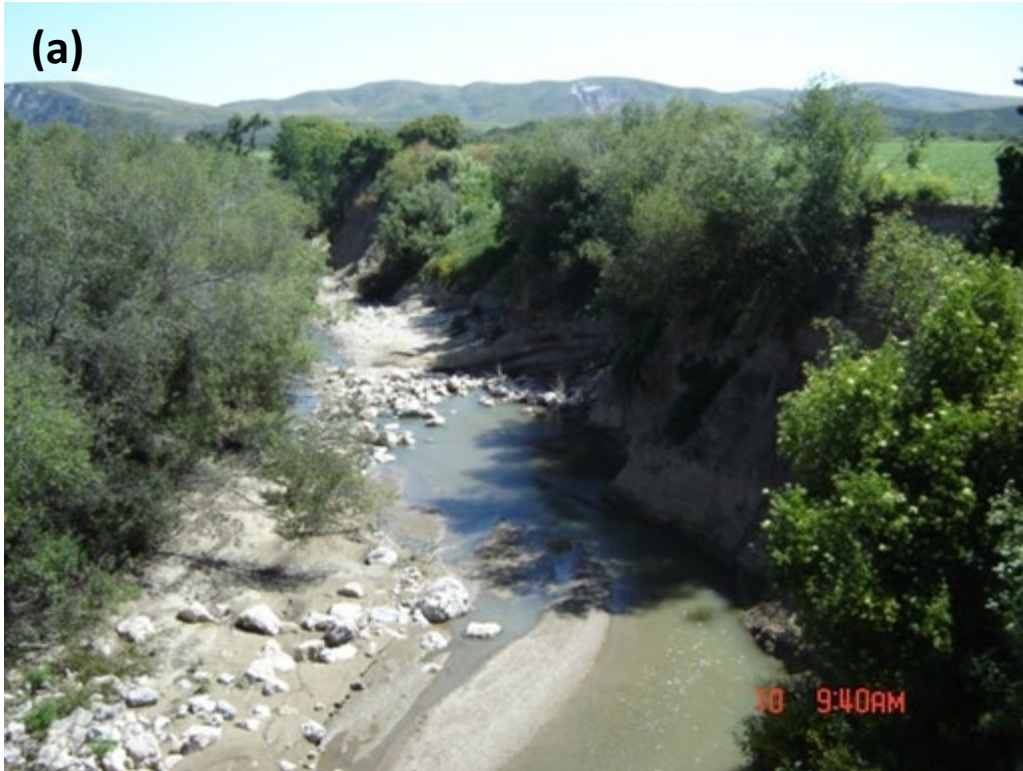
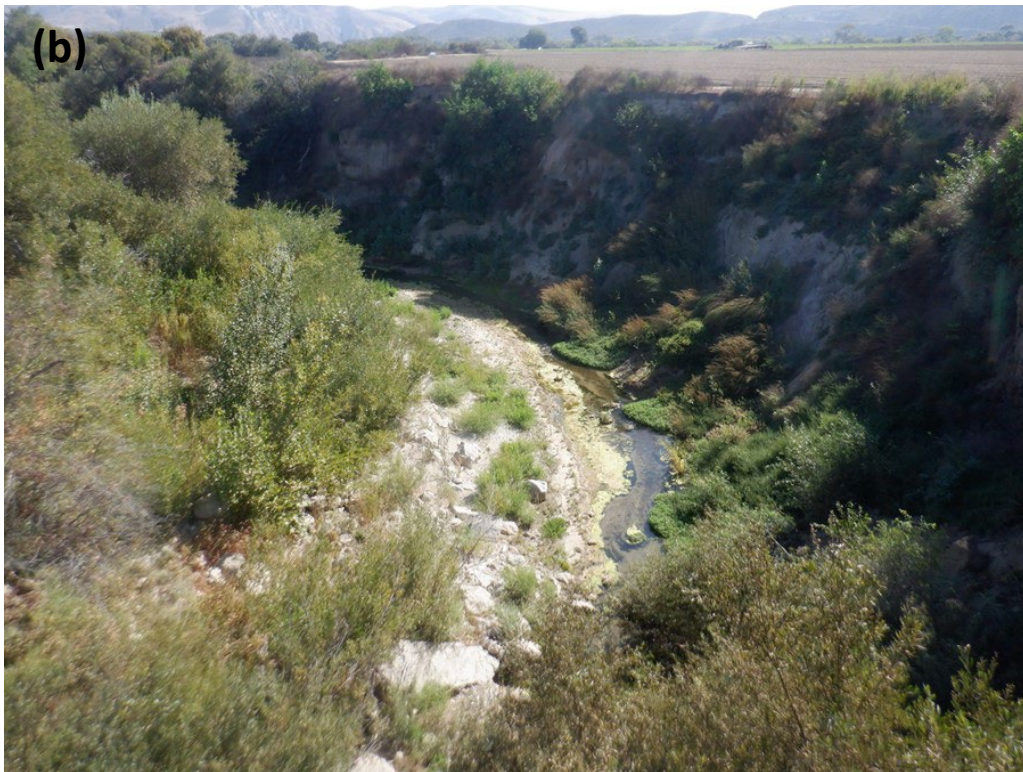
Figure 66: Photo point (T-28) collected at Salsipuedes Creek at Santa Rosa Bridge looking downstream in (a) May 2005 and (b) September 2024.

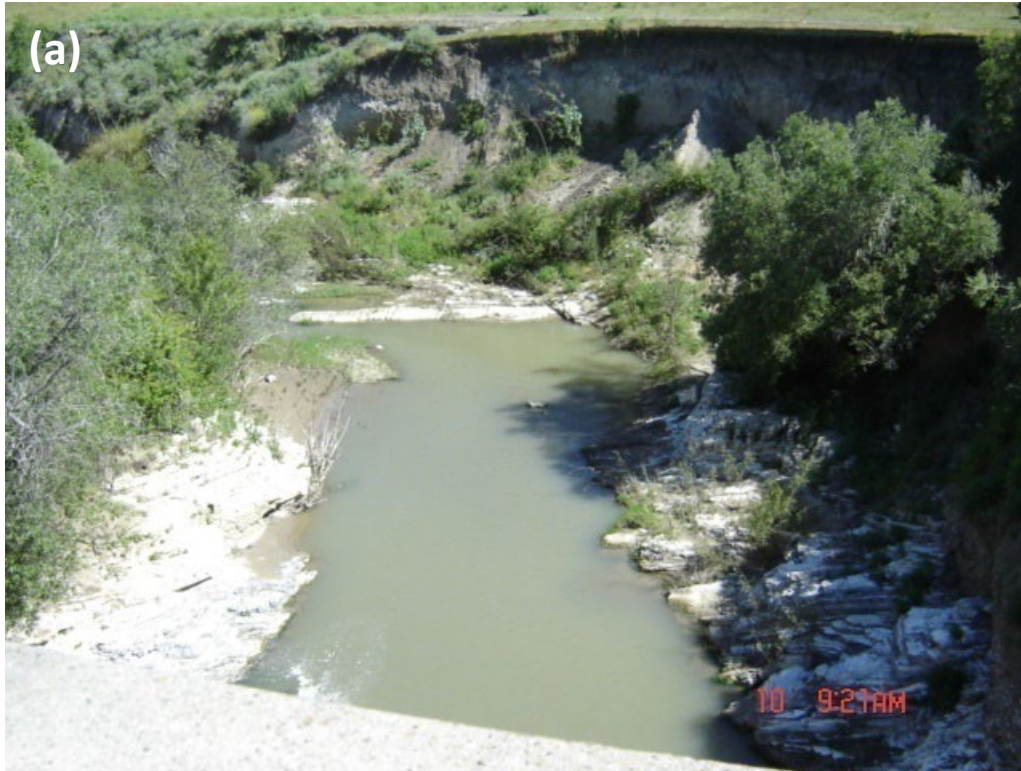
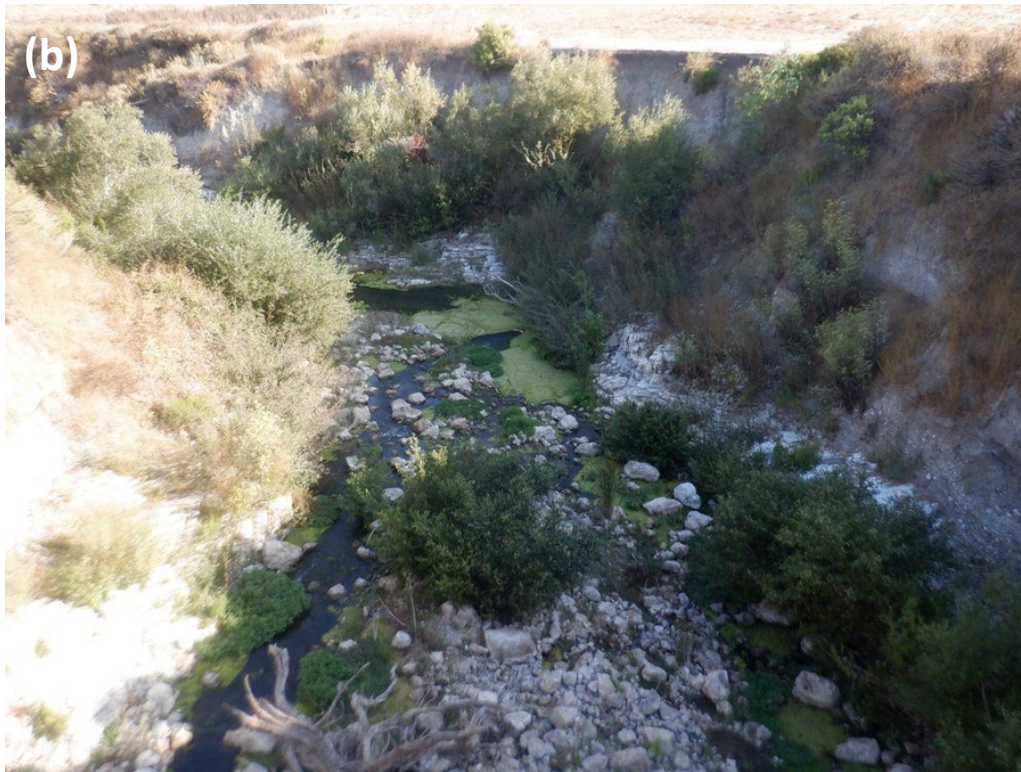
Figure 67: Photo point (T-39) collected at Salsipuedes Creek at Hwy 1 Bridge in May 2005 and (b) September 2024 (Post CalTrans Hwy 1 Bridge Replacement Project-continues to unravel).

Figure 67: Photo point (T-39) collected at Salsipuedes Creek at Hwy 1 Bridge in May 2005 and (b) September 2024 (Post CalTrans Hwy 1 Bridge Replacement Project-continues to unravel).

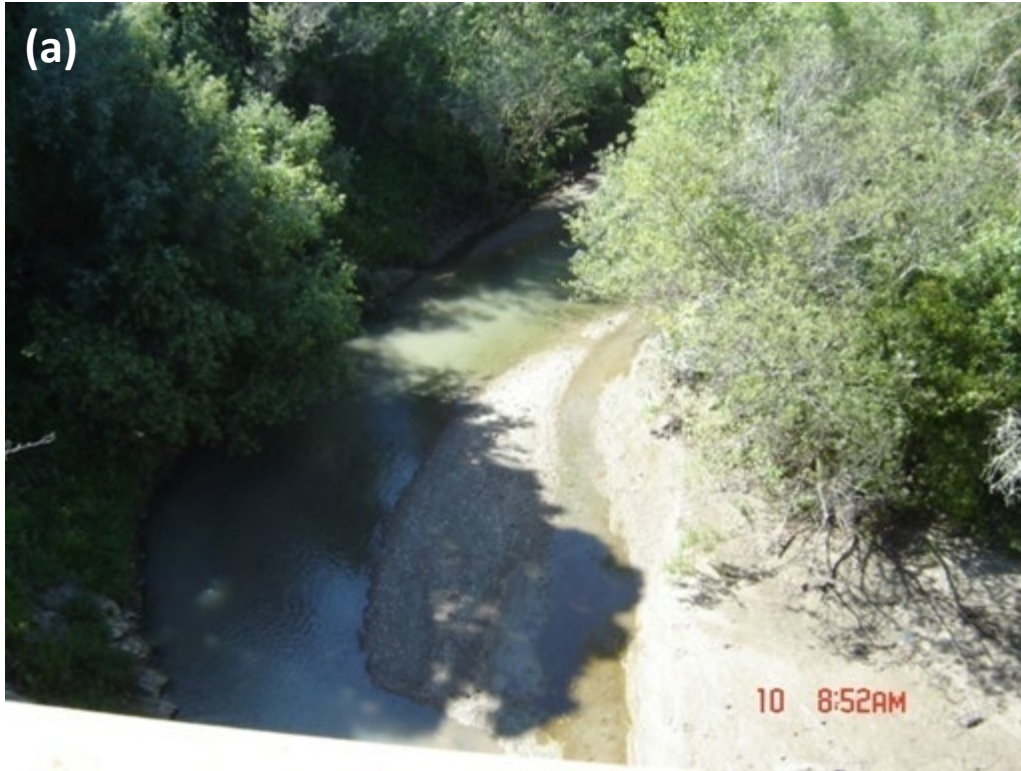
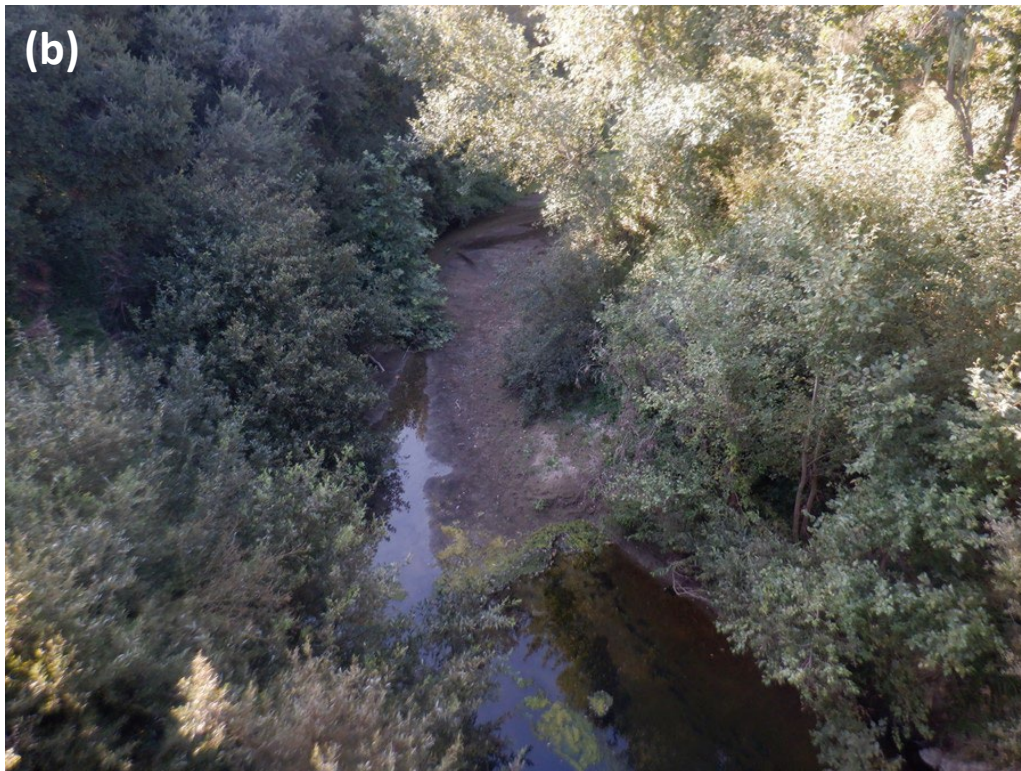
Figure 68: Photo point (T-42) collected at Salsipuedes Creek at Jalama Road Bridge in May 2005 and (b) September 2024.

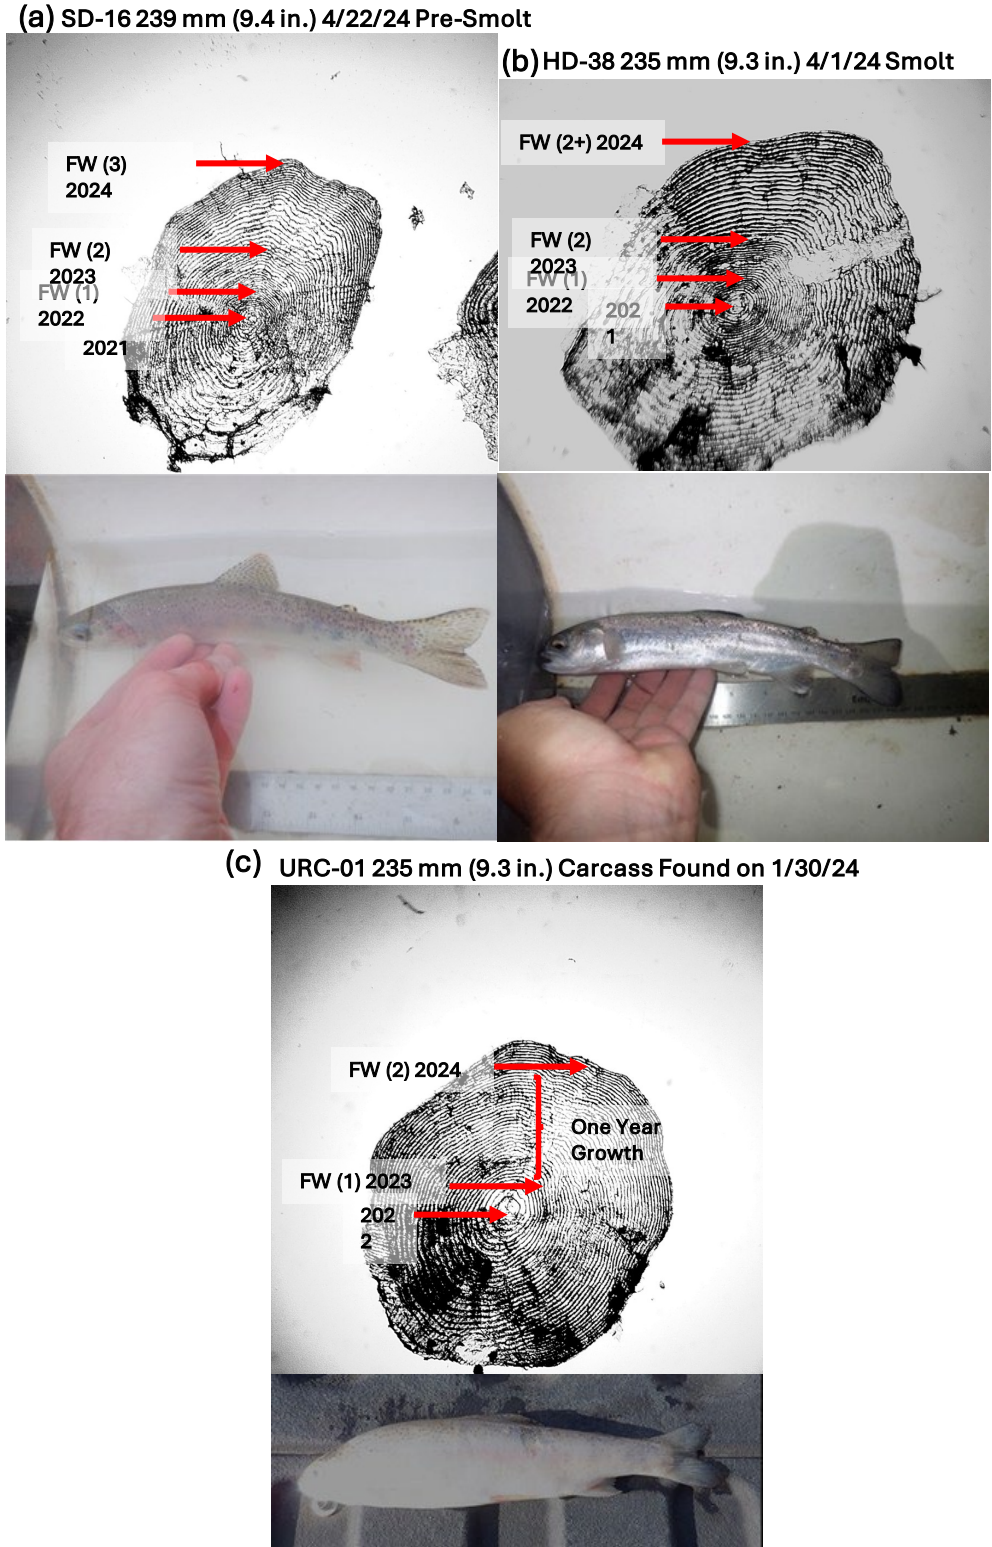
Figure 108: Comparison of similar sized fish growth patterns of two smolting *O. mykiss* captured in (a) Salsipuedes Creek, (b) Hilton Creek, and (c) a carcass found in the Upper Refugio Reach of the LSYR mainstem.

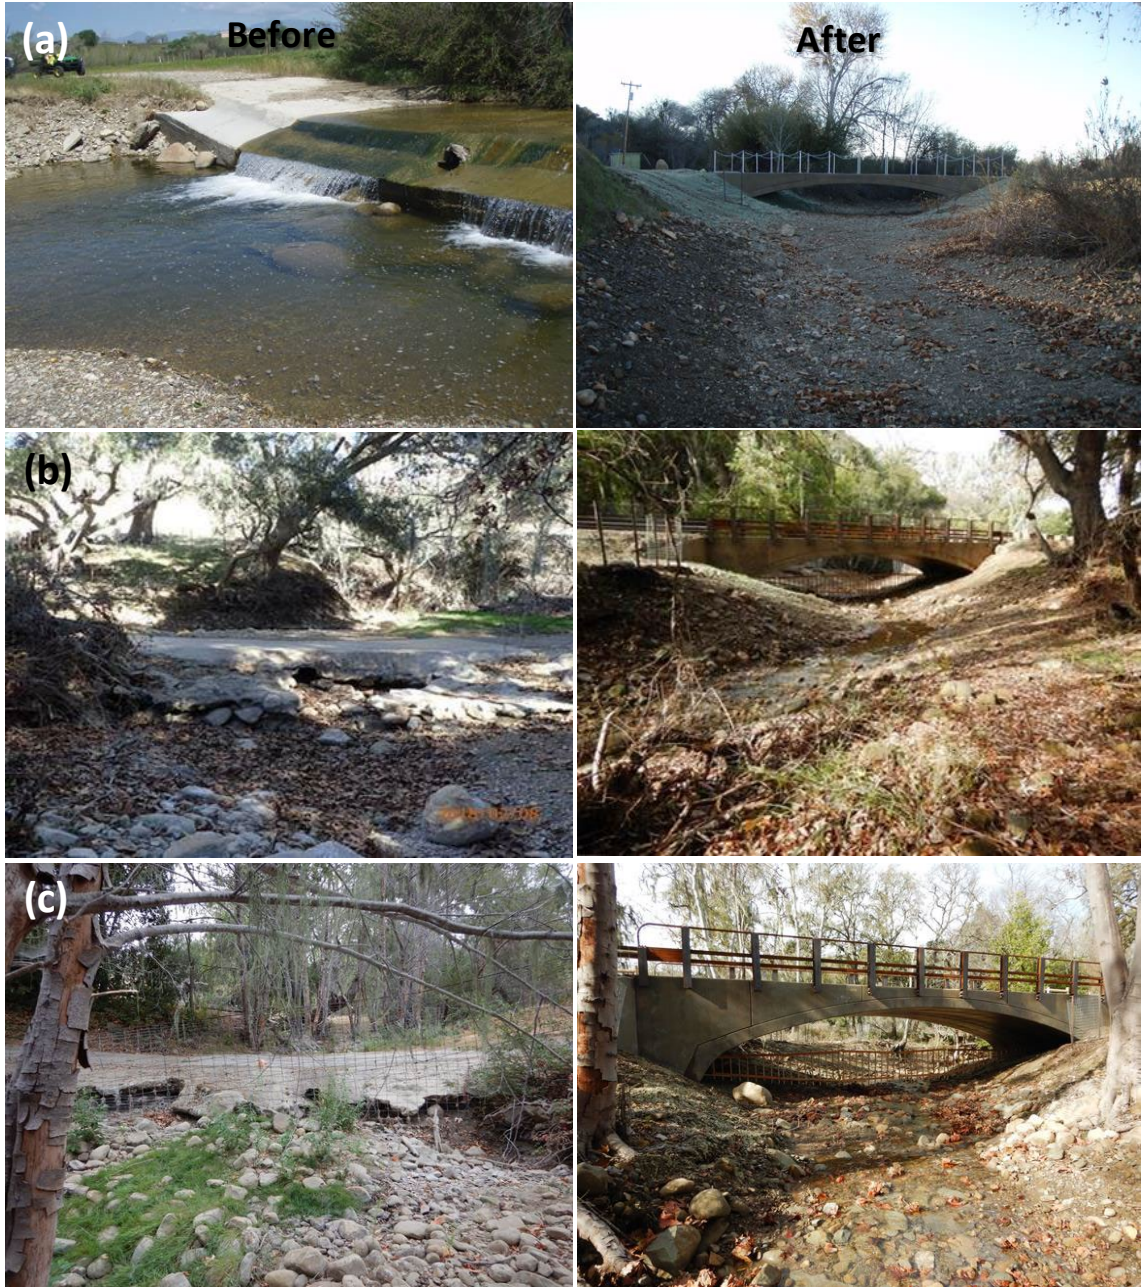
Figure 122: Fish passage and habitat restoration at (a) Quiota Creek Crossing 0A (2015), (b) Quiota Creek Crossing 5 (2018), and (c) Quiota Creek Crossing 9 (2018).

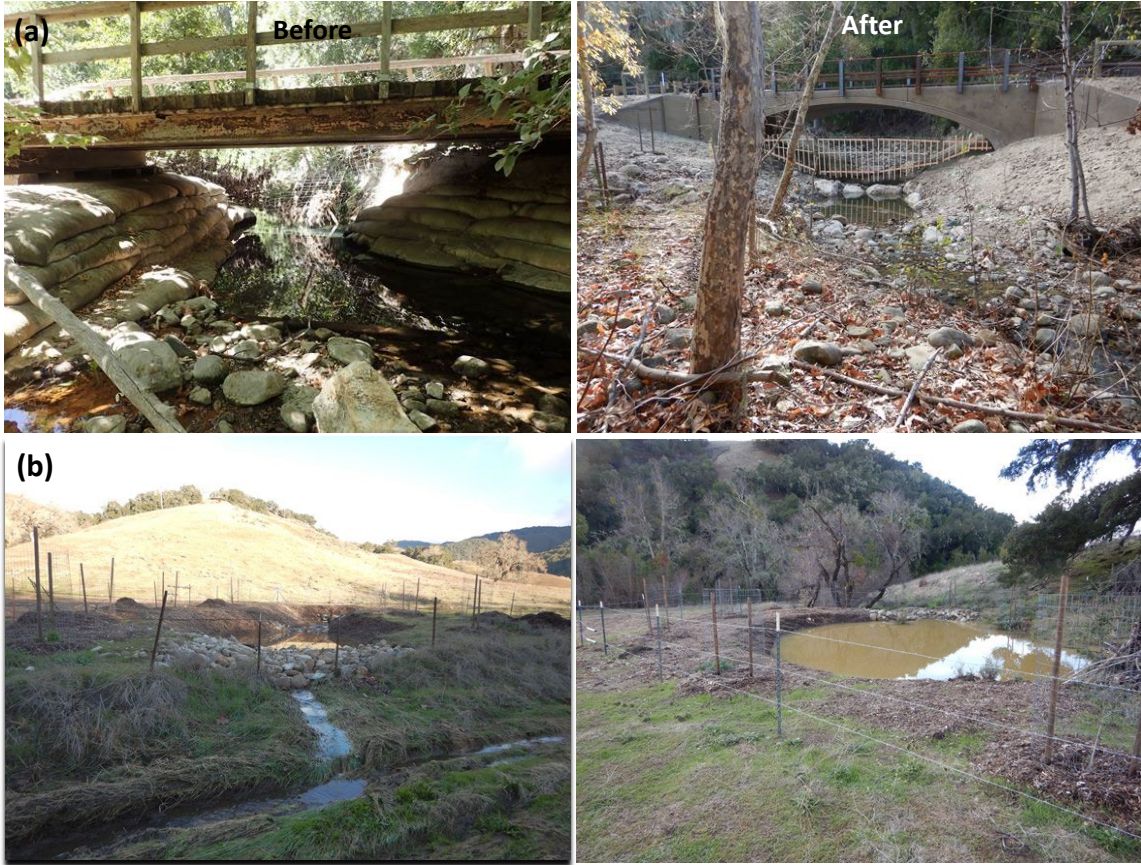
Figure 123: Fish passage and habitat restoration at (a) Quiota Creek Crossing 8 completed in 2019 and (b) South Side Erosion Control and Reforestation Project at Crossing 8 (completed in 2020).
