WY2024 ANNUAL MONITORING SUMMARY

THE BIOLOGICAL OPINION FOR THE OPERATION AND MAINTENANCE OF THE CACHUMA PROJECT ON THE SANTA YNEZ RIVER IN SANTA BARBARA COUNTY, CALIFORNIA

**CACHUMA OPERATION AND MAINTENANCE BOARD
FISHERIES DIVISION**

MARCH 4, 2025

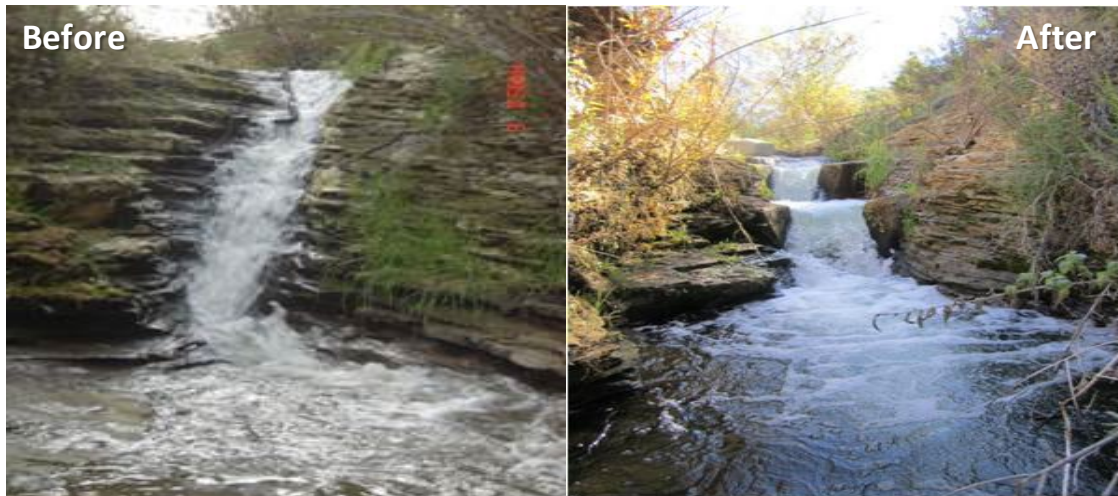
Figure 124: Fish passage and habitat restoration at Hilton Creek at the Cascade Chute Project that was completed in 2005.

The deliveries from the HCWS/HCEBS have transformed Hilton Creek into a dense riparian corridor where there is little thermal heating from the URP to the confluence with the LSYR mainstem. In 2005, completion of the Hilton Creek Cascade Chute Project doubled the available habitat for *O. mykiss* in the watered section of Hilton Creek and releases from the URP provided for extensive riparian vegetation growth that has shaded and cooled the stream water (Figures 124 and 125). Channel changes and the redistribution of optimal sized spawning gravels throughout Hilton Creek from the Whittier Fire, coupled with continuous Lake Cachuma water deliveries to the URP since WY2019, and gravel augmentation (2017-2018 while present and before being washed out) have greatly enhanced instream spawning and rearing conditions throughout the creek.

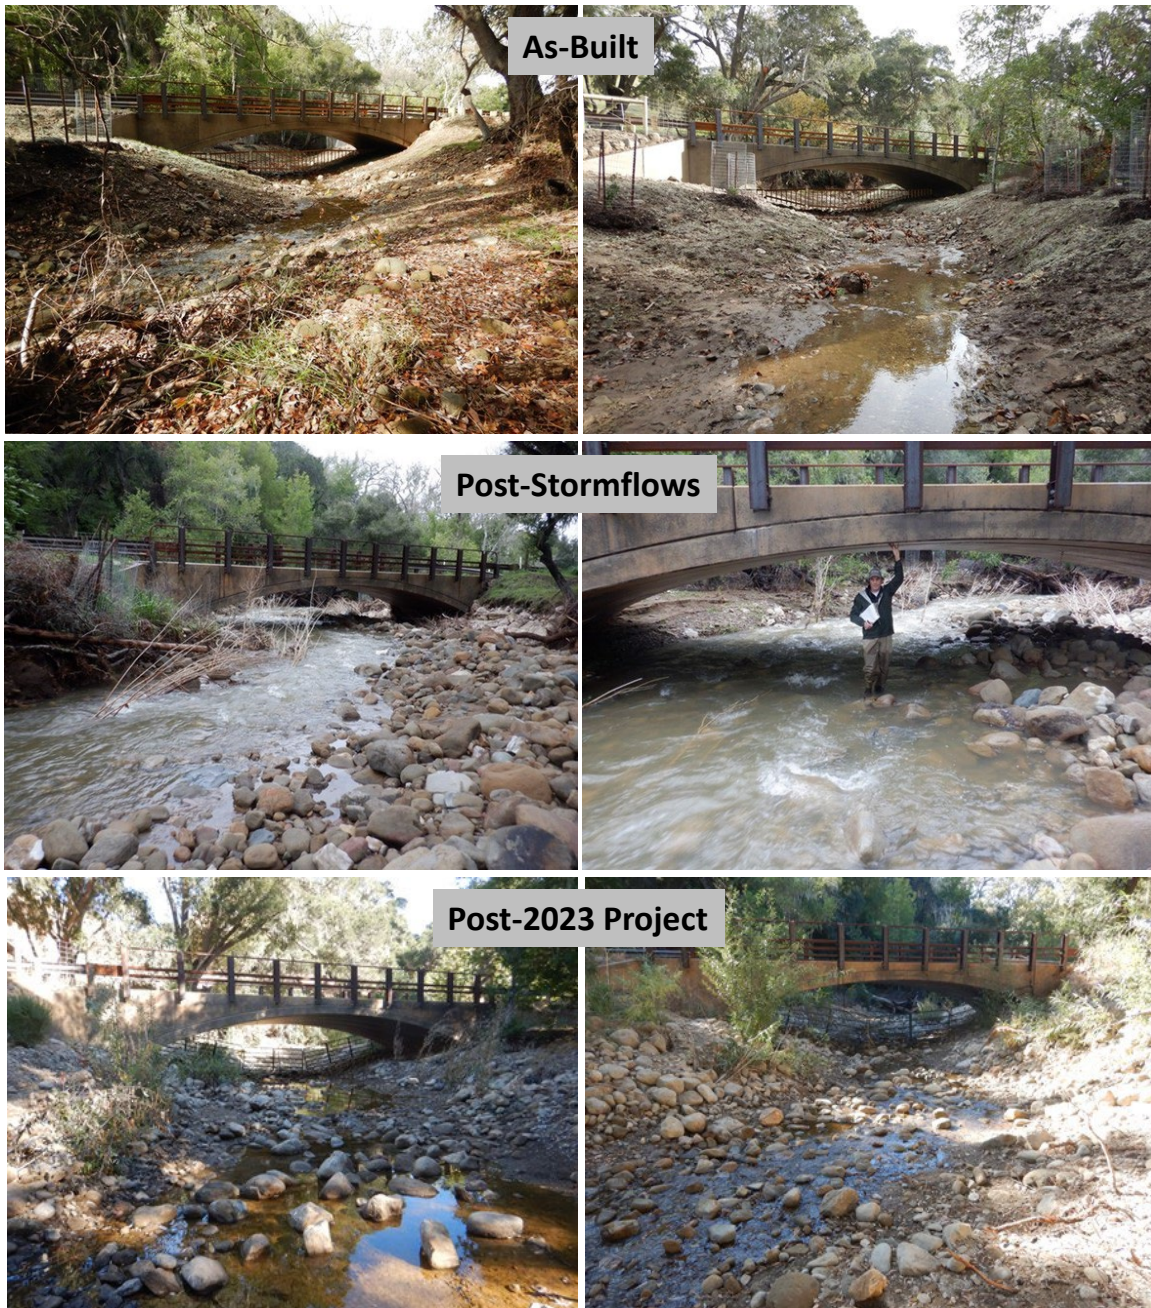
Figure 126: Quiota Creek Crossing 5 showing the As-Built, post-stormflows and post 2023 project conditions.

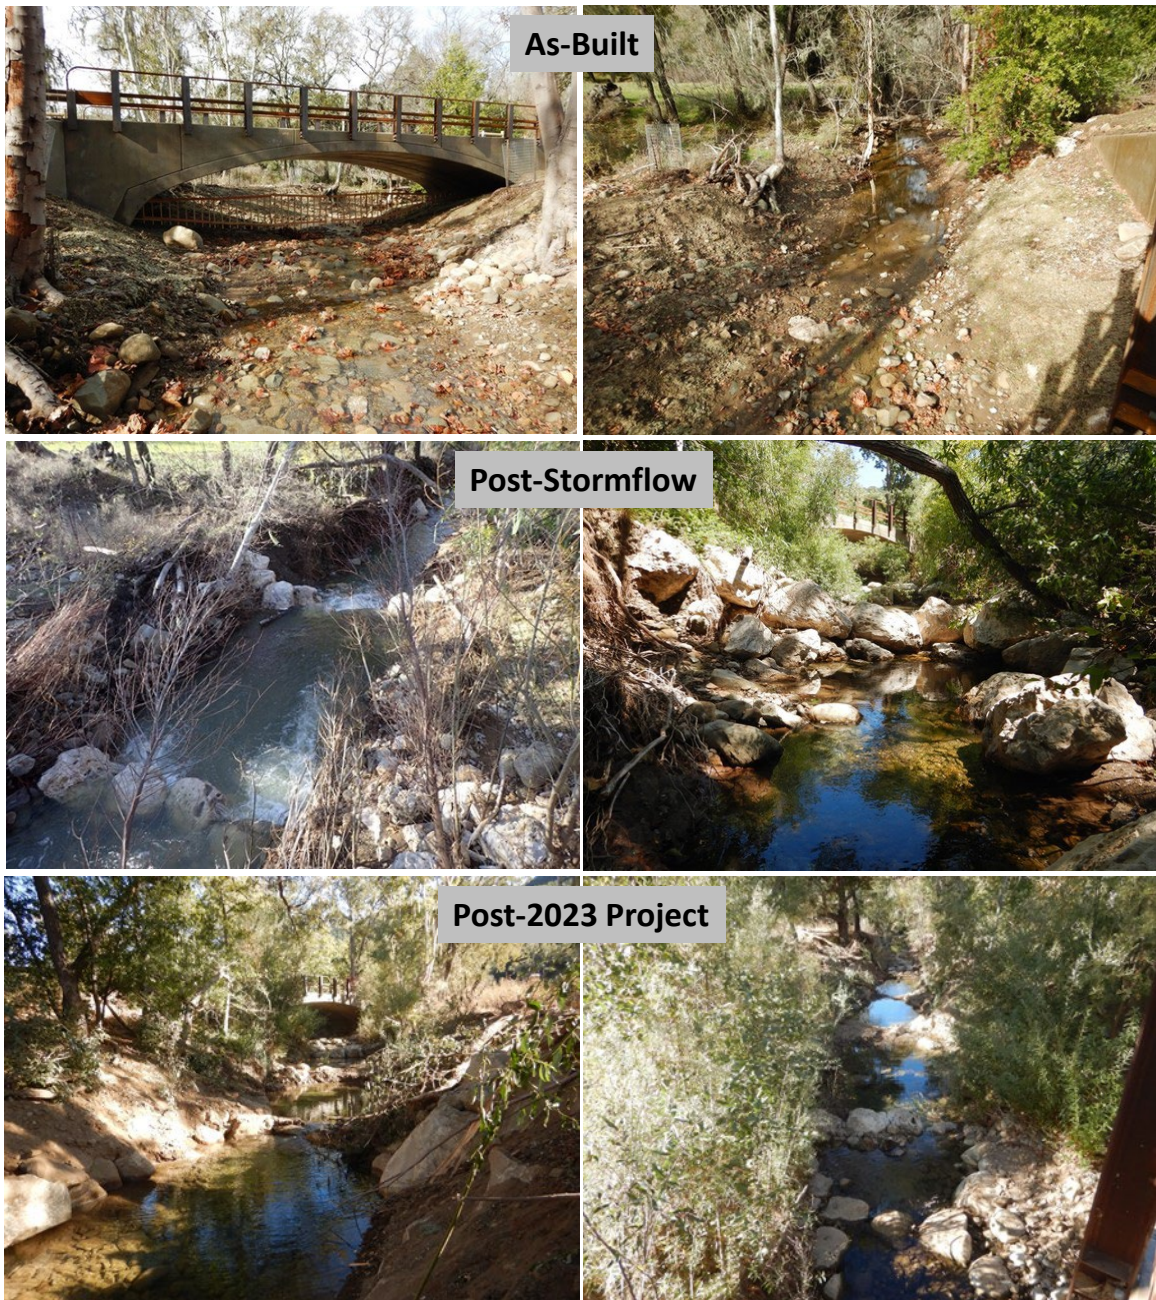
Figure 127: Quiota Creek Crossing 9 showing the As-Built, post-stormflows and post 2023 project conditions.

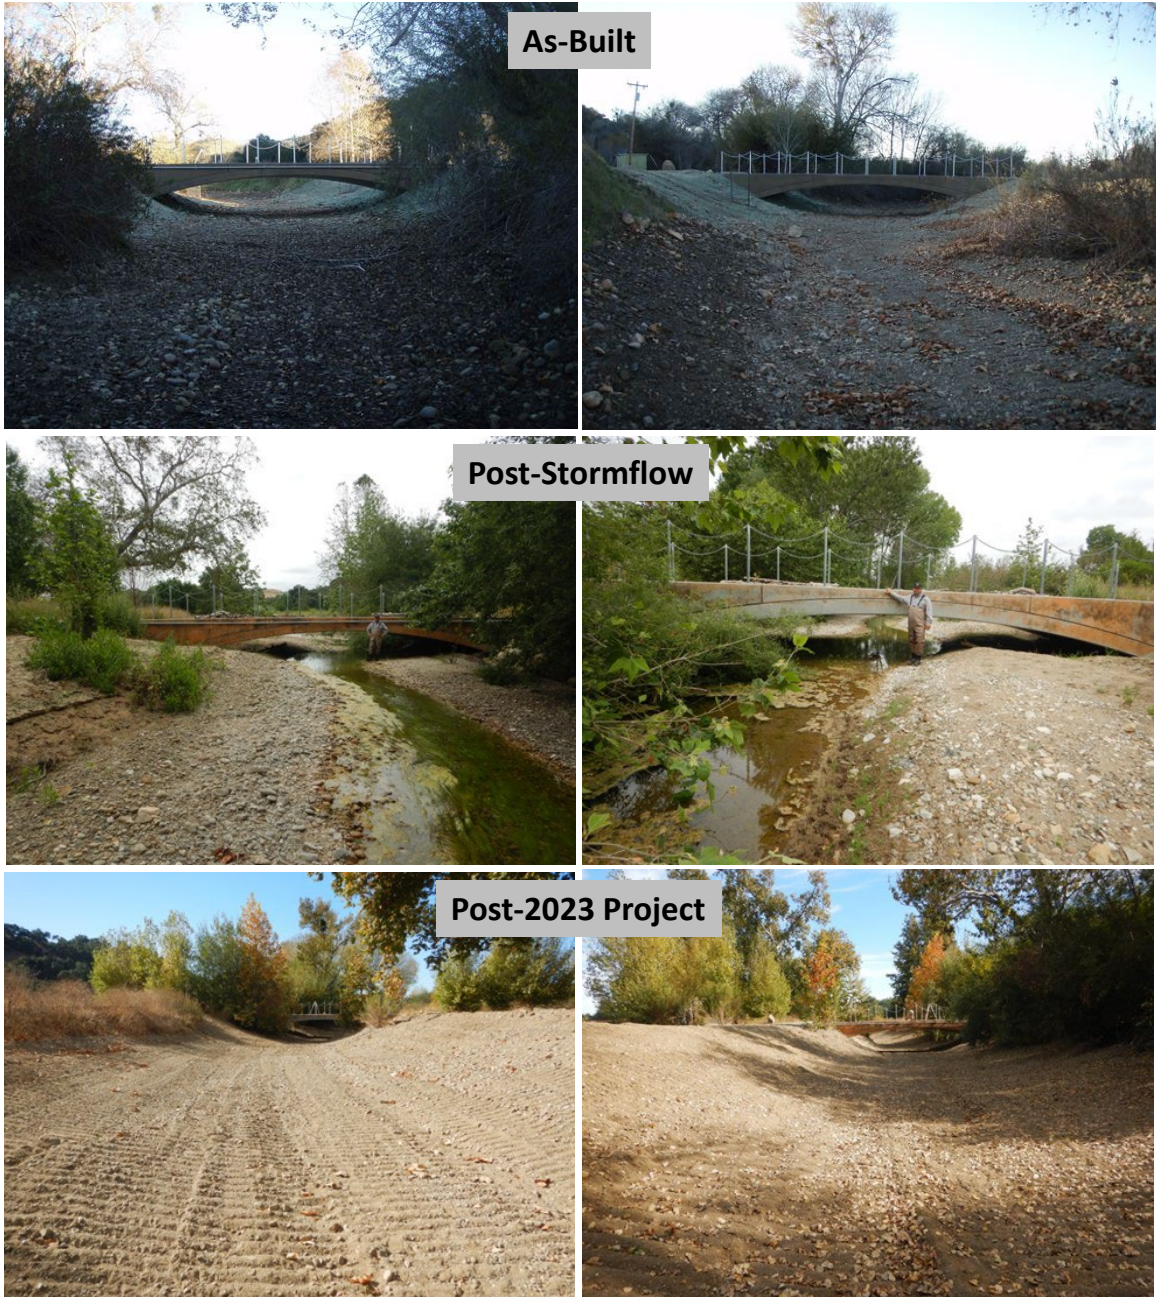
Figure 128: Quiota Creek Crossing 0A showing the As-Built, post-stormflows and post 2023 project conditions.

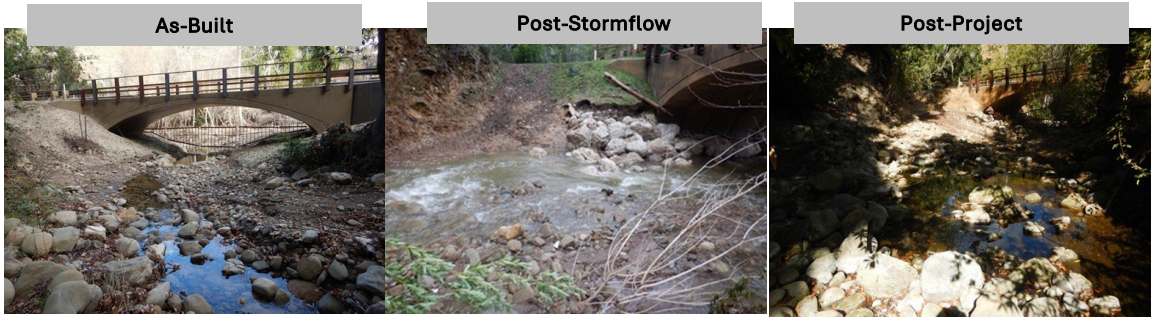
Figure 129: Quiota Creek Project at Crossing 8 showing the As-Built, post-stormflows and post 2024 project.

Heavy rainfall and subsequent stormflow events in WY2023 and WY2024 damaged some of the instream elements of several previously completed COMB tributary restoration projects. To bring them back to the As-Built condition or better to address climate change, COMB successfully completed in the fall of 2023 repairs and enhancements on instream constructed elements on Quiota Creek at Crossings 5 and 9 (Figures 126 and 127) and the landowner did the same at Crossing 0A (Figure 128). In the fall of 2024, COMB successfully completed in the fall repairs and enhancements on Quiota Creek at Crossings 8, 4, 3 and 1 (listed in the order of construction) (Figures 129-132) plus on El Jaro Creek at Rancho San Julian (Figure 133). The landowner finally removed the partial fish passage barrier at Quiota Creek Crossing 0B in October (2024) and just left it as an at-grade dirt crossing (Figure 134).

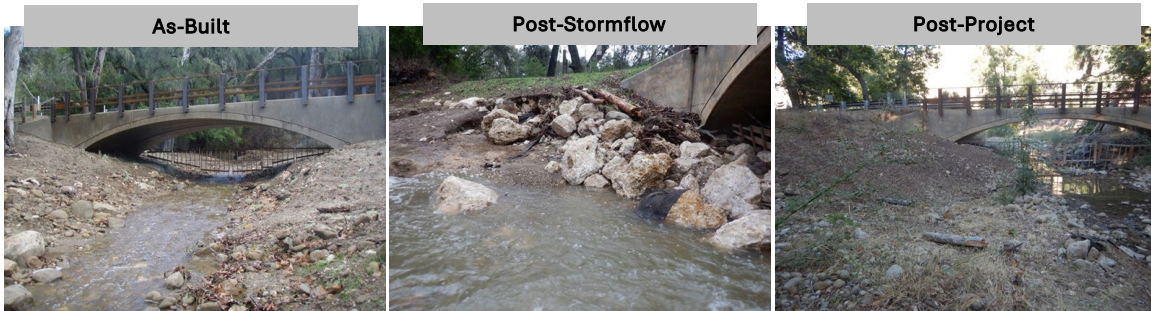
Figure 130: Quiota Creek Project at Crossings 4 showing the As-Built, post-stormflows, and post 2024 project.

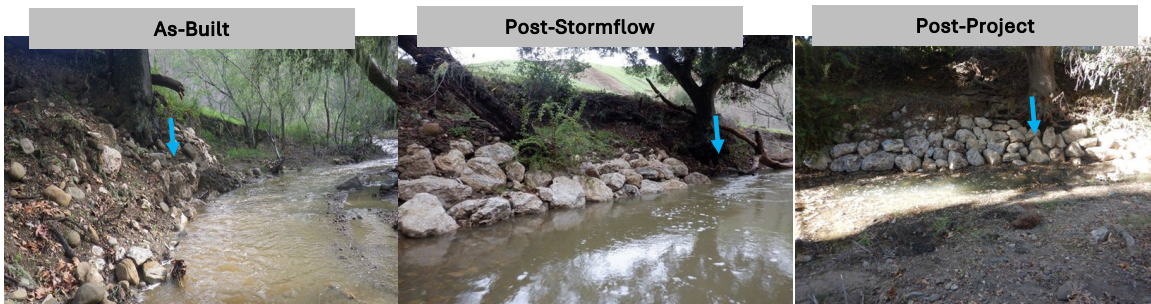
Figure 131: Quiota Creek Project at Crossing 3 showing the As-Built, post-stormflows, and post 2024 project.

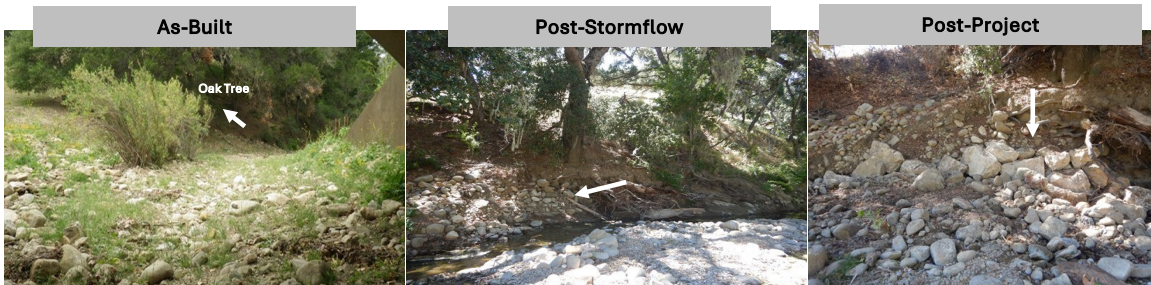
Figure 132: Quiota Creek Project at Crossing 1 showing the As-Built, post-stormflows, and post 2024 project.

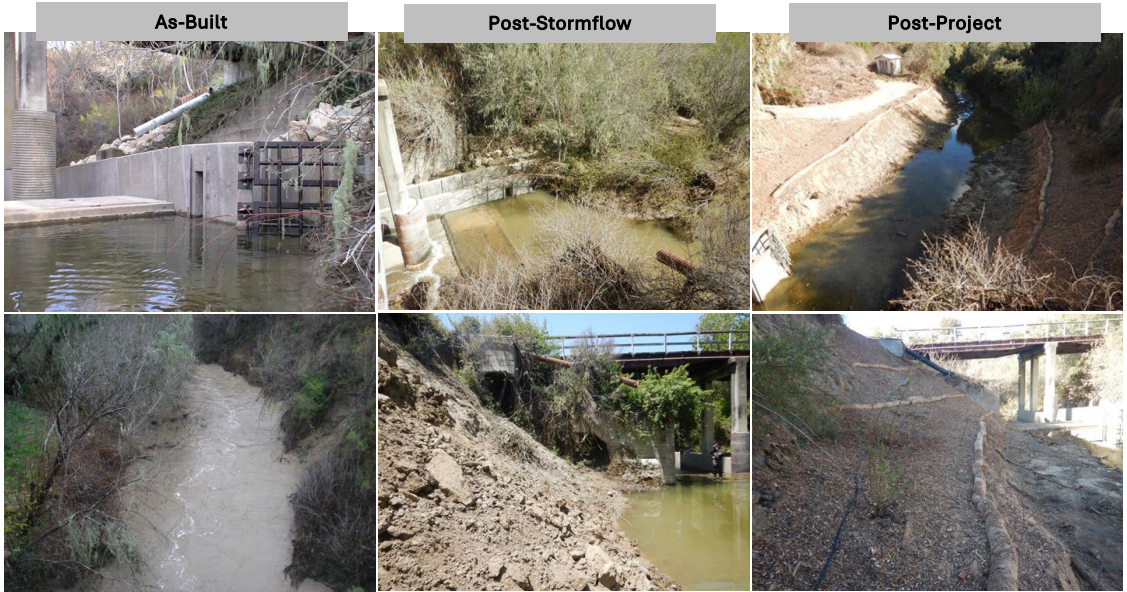
Figure 133: El Jaro Creek at Rancho San Julian Project showing the As-Built, post-stormflows and post 2023 project.

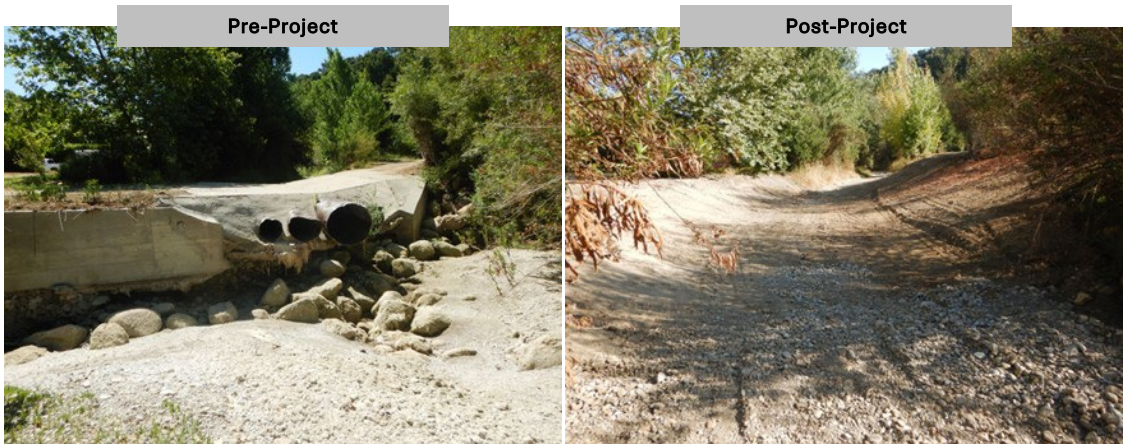
Figure 134: Quiota Creek Crossing 0B, the landowner finally removed their low flow concrete crossing that was a partial barrier to fish passage.

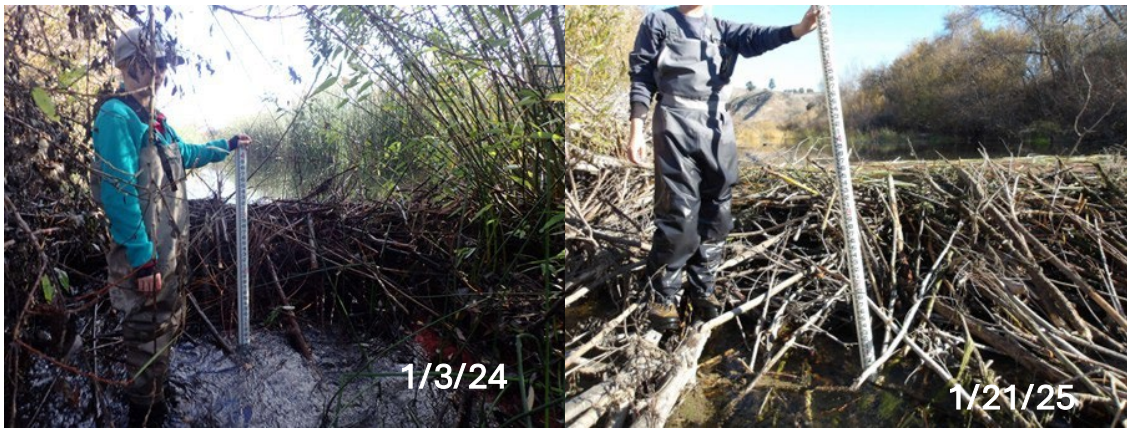
Beaver Dams - Documentation and Potential Migration Barriers: Beaver dams have been observed to act as migration barriers on the LSYR mainstem and tributaries especially during low to moderate water years (Figure 135). They can fragment habitats and force *O. mykiss* to spawn in suboptimal locations as they are unable to negotiate past large well-established dams. This was evident in WY2021 when two large anadromous steelhead redds were identified 1.5 miles upstream of the Salsipuedes Creek confluence and 0.9 miles downstream of a significant beaver dam within the Narrows Reach. The steelhead spawned in the only area available that consequently went dry before the eggs hatched. Upon inspection of that beaver dam following the discovery of the steelhead redds, it was clear that the dam was a complete barrier to any upstream migrating fish due to the absence of a jump pool below the beaver dam, the height of the dam (2.7 feet) and no observable flow paths to enable fish to swim through or around the dam. Without the presence of beaver dams (80 recorded in the LYSR mainstem in WY2021), it was likely those fish could have moved upstream into tributaries with more suitable habitats such as Hilton Creek.

Figure 135: Examples of beaver dams that were fish passage impediments in Reach 3.
